# Manhole Inspection Summary

Manhole # S39E\_\_018MH

**Location** Address: **1027 e.baltimore st**

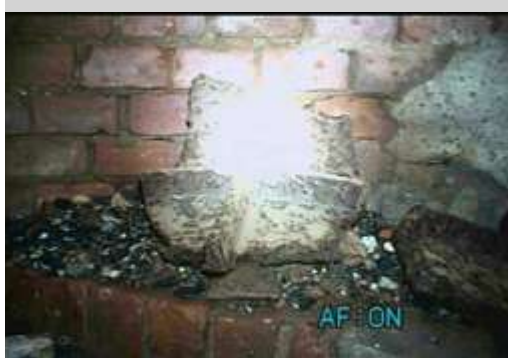
Miscellaneous

bench debris

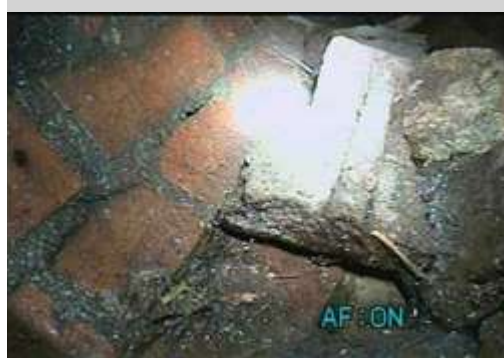
Miscellaneous

channel debris

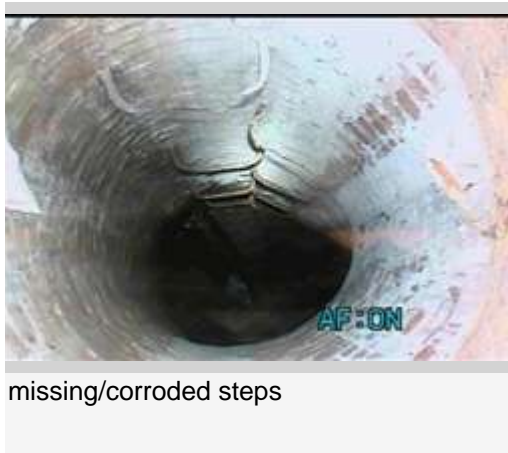
Defect 5

Count: **8** Missing: **1** ☒ **Corroded**

missing/corroded steps

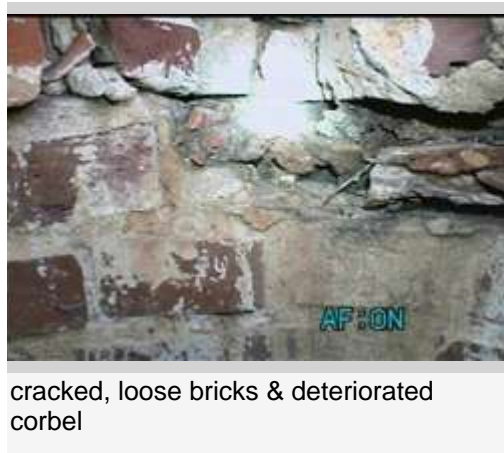
Defect 4

Condition: ☐ Sound ☒ **Cracked** ☐ Root Intrusion ☒ **Loose Brick** ☒ **Deteriorated**

cracked, loose bricks & deteriorated corbel

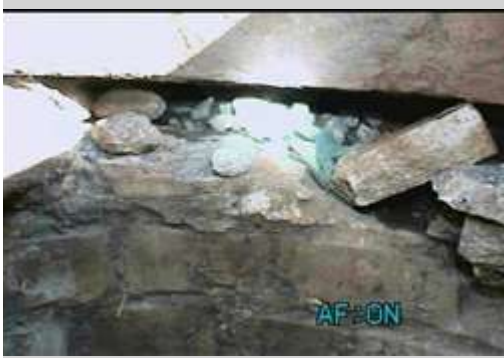
Defect 3

Condition: ☐ Sound ☐ Cracked ☐ Root Intrusion ☒ **Loose Brick** ☒ **Deteriorated**

Cracked Chimney loose bricks  
deteriorated frame adj

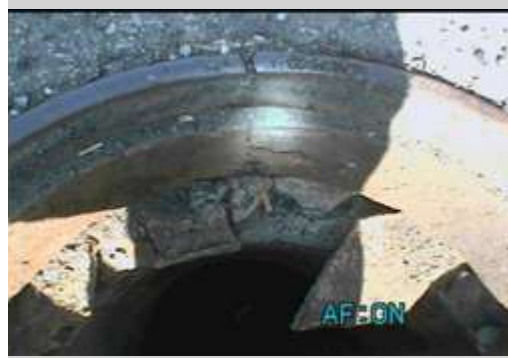
Defect 2

Offset: **3** (in.)

Condition: ☐ Sound ☒ **Cracked** ☐ Leaks

frame cracked & offset

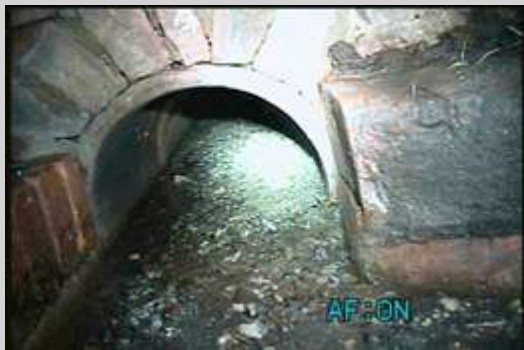
12 O'Clock Outflow

Deposits: ☐ None ☐ Mud ☐ Sludge ☒ Debris ☐ Grease

Silt Depth: 2 (in.) Deposits Extent: Heavy

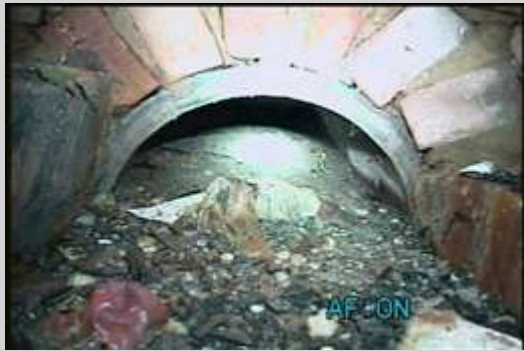
6 O'Clock Inflow

Deposits: ☐ None ☐ Mud ☐ Sludge ☒ **Debris** ☐ Grease

Silt Depth: **4** (in.) Deposits Extent: **Medium**

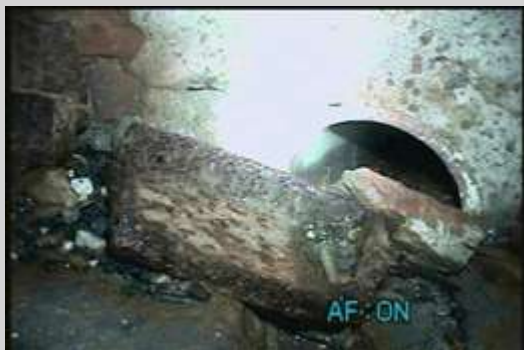
9 O'Clock Inflow

Deposits: ☐ None ☐ Mud ☐ Sludge ☒ **Debris** ☐ Grease

Silt Depth: **3** (in.) Deposits Extent: **Light**
